Failure analysis of duplex 2205 gas separator welds

Pekka Nevasmaa¹ & Sanni Yli-Olli¹

¹VTT Technical Research Centre of Finland Ltd
Espoo, Finland

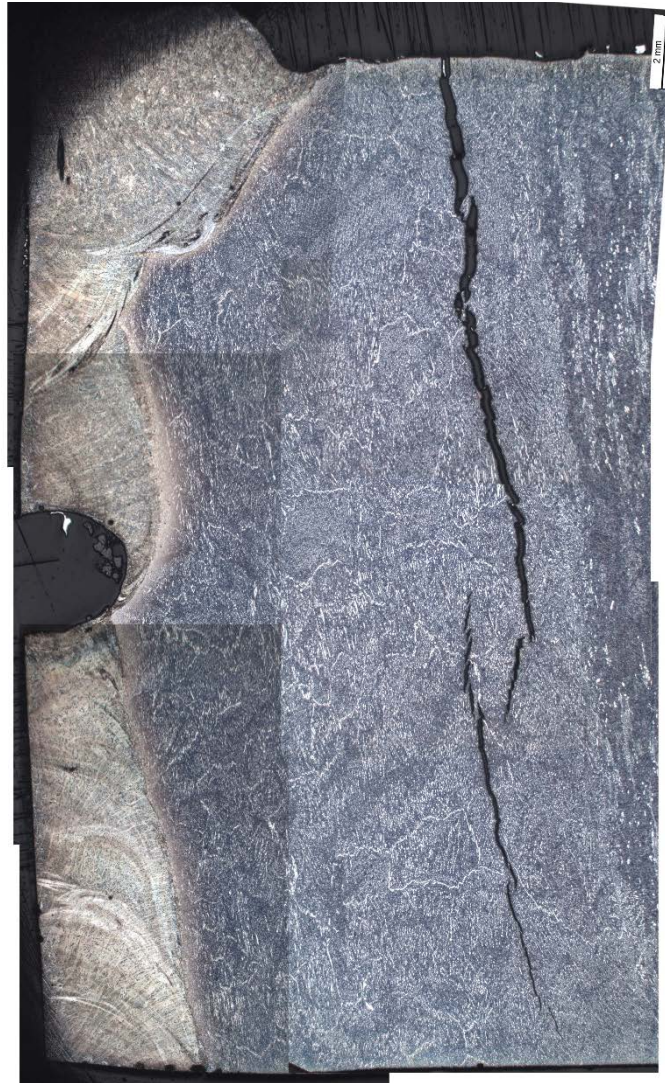
Figure 1. Cross section sample from a cracked detail: crack initiation at the plate surface close to the weld (left), crack propagation nearly through the entire section thickness, with occasional crack branching.

Additionally, the welded sides of samples cut along the weld centerline revealed internal volumetric imperfections and defects within the weld metal close to the weld centre region in the plate thickness direction (c.f. Figure 1). These imperfections imply that welding of the weld root region, in this respect, had technically failed, which, in turn, had prevented achieving a sound weld root and hence resulted in poor weld quality.

According to the LOM microscopy of the cross section samples, the main cracks appeared very deep; they had propagated nearly through the entire section thickness (Figure 1). Several individual microcracks, of which one has grown to a main crack, were discovered on the plate outer surface (Figure 7). Various secondary microcracks, as well as pronounced crack branching and crack bridging were also found along the crack propagation path.

copy revealed no evidence of the presence of any *brittle metallic phases*, such as sigma phase. The discovered internal volumetric *imperfections within the weld metal* close to the weld root region (c.f. Figure 1) imply that welding of the root had technically failed in this respect; however, the weld metal defects were not in direct connection to the observed failure and are hence of secondary importance in this sense.

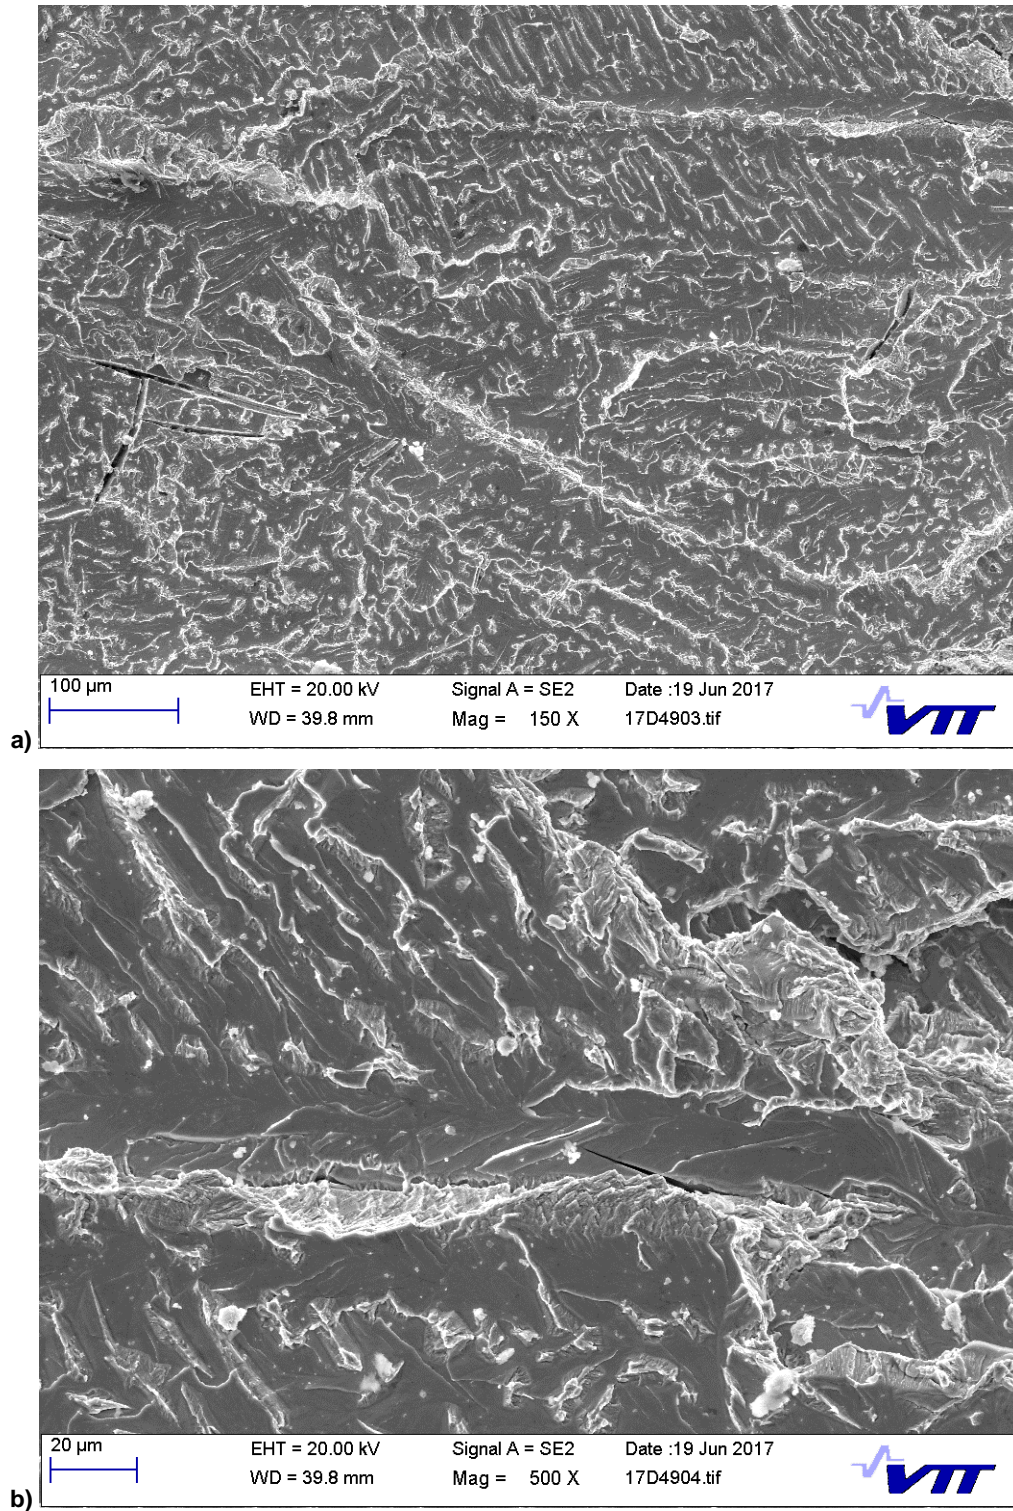
The results of the fractographic investigation using scanning electron microscopy (SEM) with energy dispersive X-ray spectroscopy analysis (EDS) are shown in Figures 2–5. The fracture surface had two different types of dominating areas. The first type was relatively flat showing several side cracks with random orientation, as well as ridges and very few striations and “feathery” like fracture propagation (Figures 2, 4 and 5). The second areas were smaller and revealed often relatively steep level changes between the flat areas, showing dimples and more ductile fracture propagation (Figure 3).

Figure 2. Fracture surface near the plate outer surface, showing “flat” fracture and side cracks. (a) Outer surface on top, fracture propagation from top to bottom; (b) detail of the fracture surface in (a).

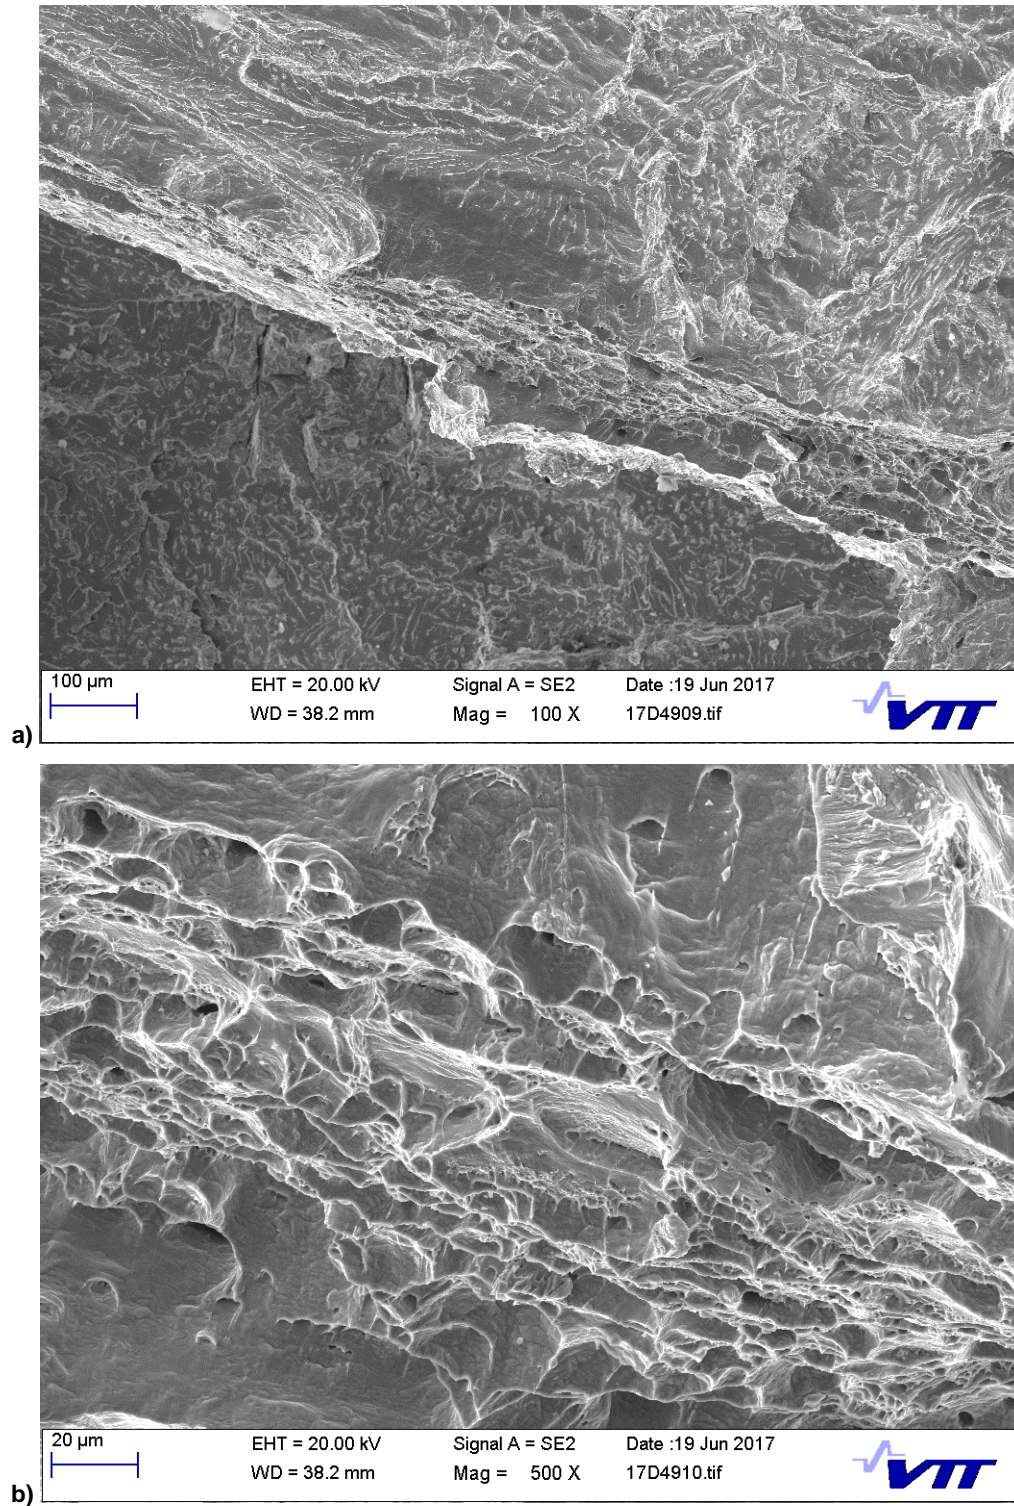
Figure 3. Fracture surface from the middle of the sample, showing level changes and dimples. (a) Outer surface on top, fracture propagation from top to bottom; (b) detail of the fracture surface in (a).

- (vi) The propagating cracks typically tend to circumvent the austenite phase, rather than grow within or across it (Figure 12).
- (vii) When cracks did propagate in the austenite, the associated fracture mode was ductile tearing, i.e. ductile overload (Figure 3).

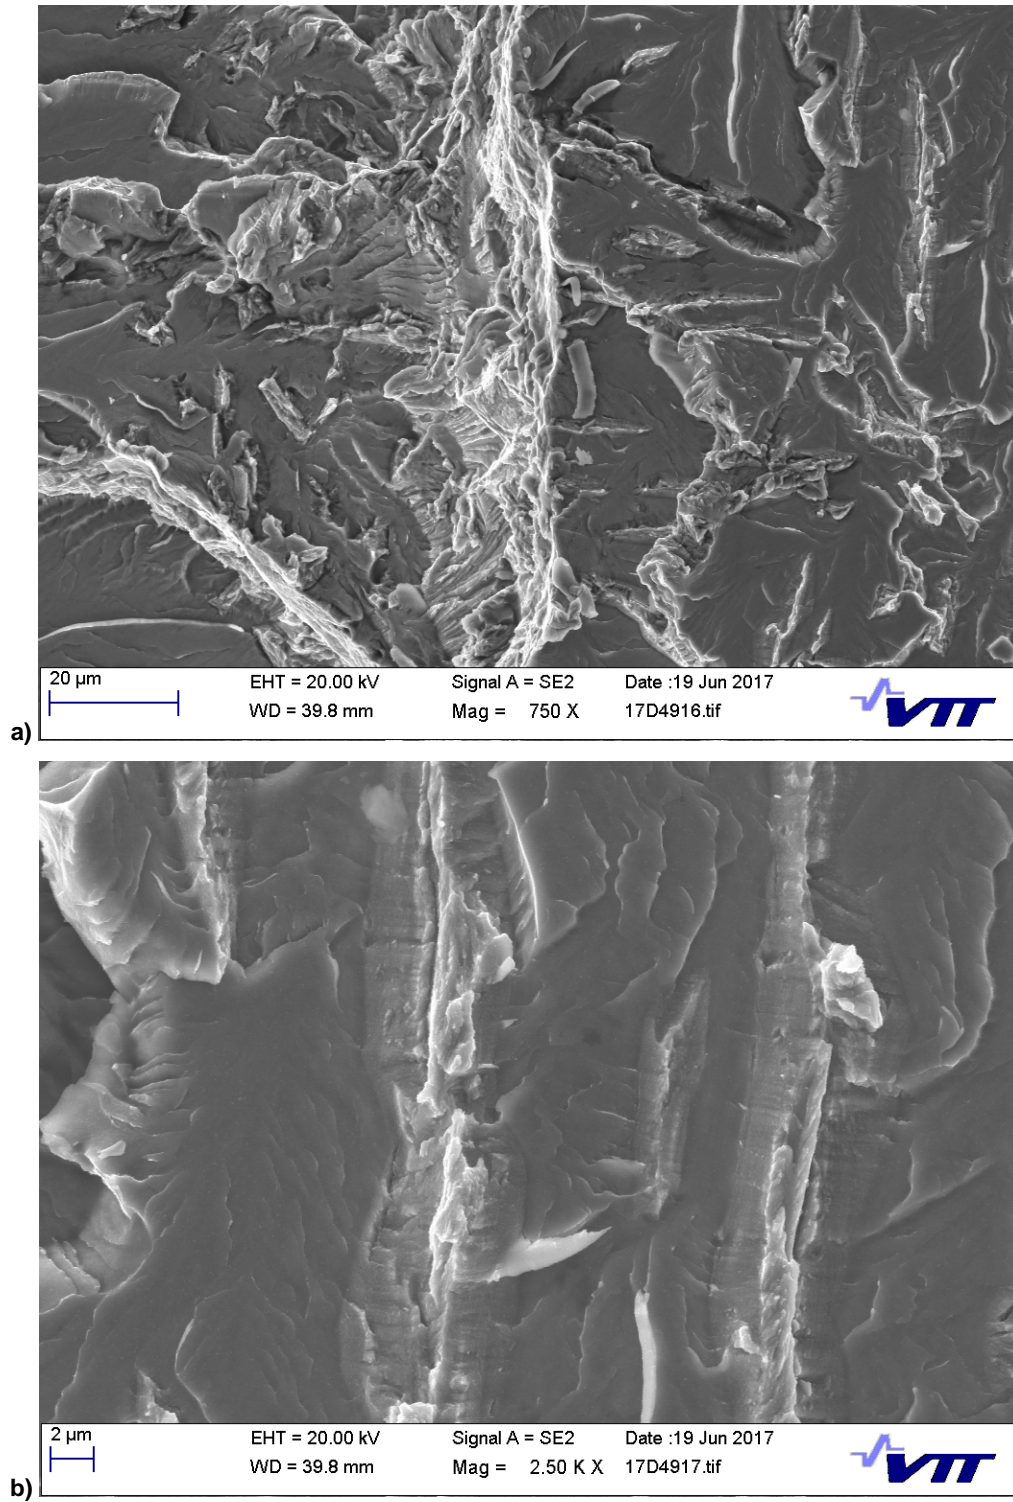
Figure 4. Fracture surface from the middle of the sample, showing (a) ridges; (b) striations. Outer surface on top, fracture propagation from top to bottom.

That the fractography revealed *local areas with striations* on the crack fracture surfaces, oriented perpendicular to the crack growth direction (Figure 4b), is considered somewhat unexpected. According to the customer, there should not have been such variable loads during the operational period of the present gas separator that are expected to cause any fatigue damage. The observed striations were therefore examined carefully, in order to rule out the possibility that they in fact could have been some kind of ridges caused by stepwise propagation of cracks provoked by the HISC mechanism. It is worth pointing out that a possibility of confusing between fatigue-associated striations and stepwise ridges caused by the HISC mechanism has been addressed in the literature. The authors opinion, however, is that the discovered features on the fracture surfaces in the present case are truly striations and, hence, an indisputable evidence of fatigue failure mechanism that has occurred at later stages of the crack propagation. Apart from striations, *ridges* were also discovered on the crack fracture surfaces (Figure 4a); however, the appearance of ridges clearly relates to a different scale of fractographic details; compare Figures 4a and 4b.

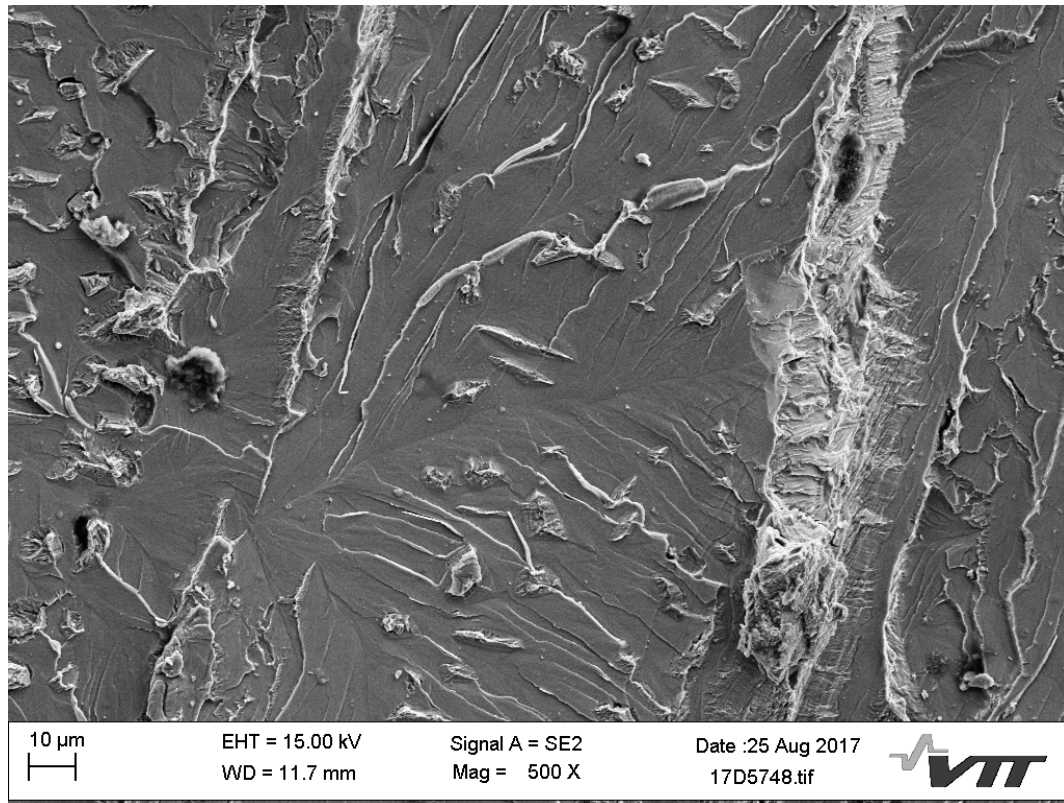
Figure 5. Fracture surface of the sample, showing features of “feathery” structure.

Literature on *hydrogen damage* reports that sc. “feathery” structure on the fracture surface accompanied by cleavage-like cracking macroscopically parallel to {100} crystallographic planes in <110> directions, with extensive slip on {111} planes intersecting transgranular cracks, has been attributed to sc. AIDE (Adsorption Induced Dislocation Emission) mechanism [5]. An example showing features of such “feathery” structure on the cleavage-like crack fracture surface in the present duplex material is given in Figure 5. The AIDE mechanism is one of the three postulated main micromechanisms associated with hydrogen-assisted cracking [5]. The features in Figure 5 can therefore be regarded as further evidence of the decisive role of hydrogen in inducing the crack initiation and assisting crack propagation in the present case. Since the examples given in the literature [5], however, were frequently associated with metallic materials other than duplex steel, the existence of the AIDE mechanism in the present case cannot be solely confirmed, nor excluded.

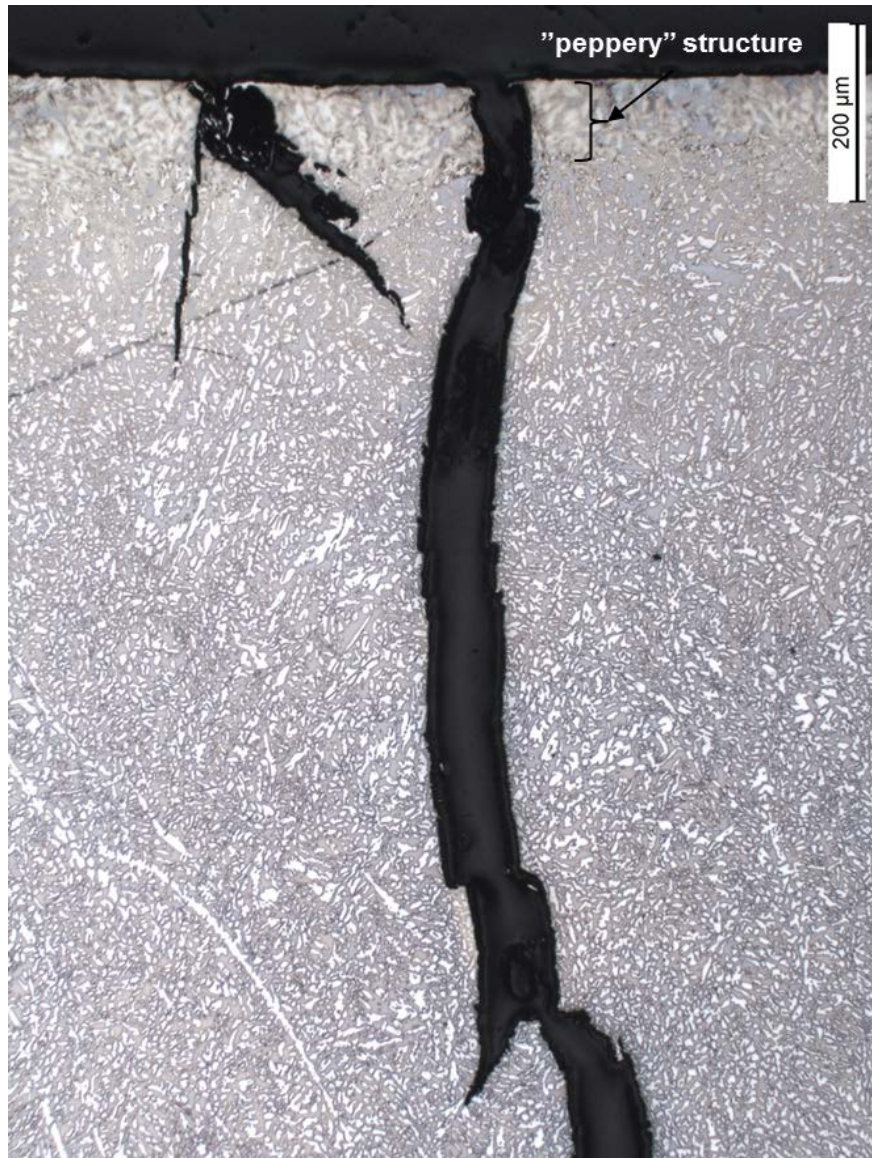
Figure 7. Crack initiation at the outer surface of the specimen close to the weldment, thin layer with "peppery" structure, several individual microcracks at the surface, crack branching along the propagation path.

- (i) The existence of multiple individual surface microcracks close to the plate outer surface, immediately adjacent to the primary crack, acting as initiation sites for HISC (Figure 7).

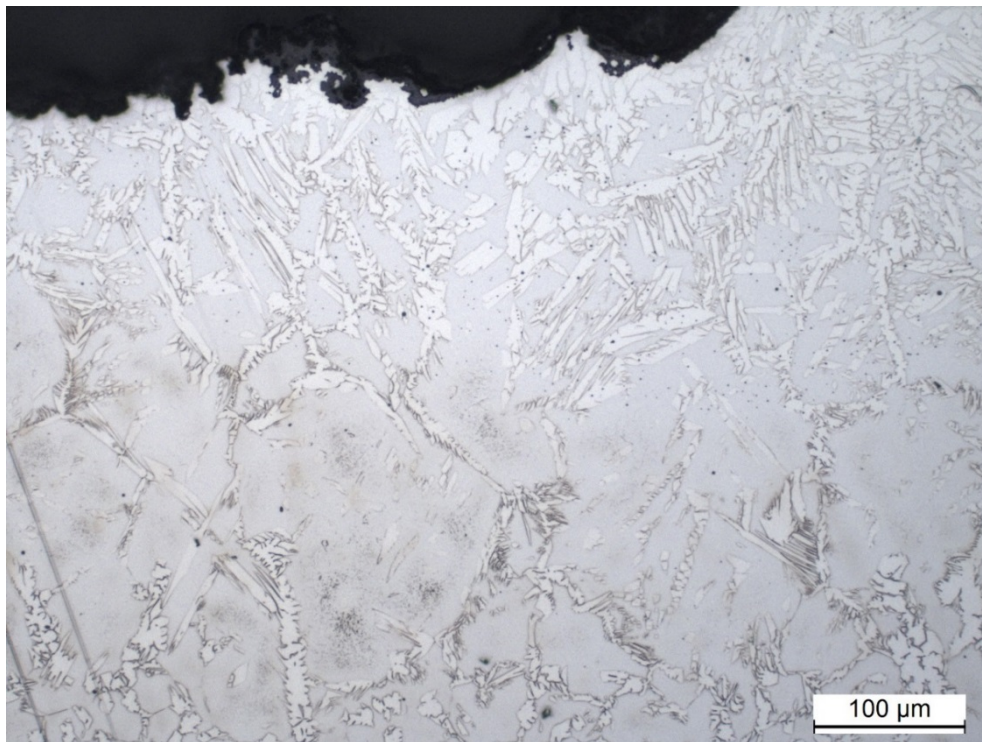
Figure 9. Detail from Figure 8. A local abnormal 'rough' surface layer adjacent to the circumferential butt-weld – grain-coarsened microstructure beneath the plate surface resembling the HAZ and composing of elongated side-plate/lath-like austenite mainly in the grain boundaries of coarse ferrite grains and traces of intragranular precipitation within the ferrite.

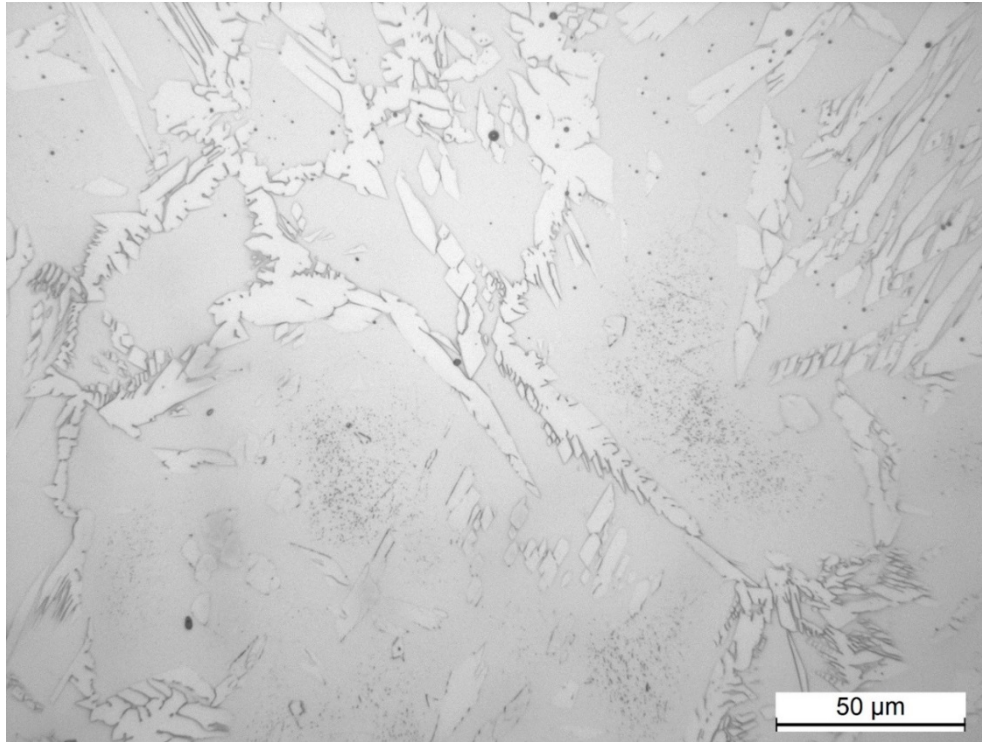
Figure 10. Detail from Figure 9. Coarse-grained microstructure beneath the abnormal 'rough' surface layer resembling the HAZ and revealing intragranular precipitation within the ferrite ("peppery" structure).

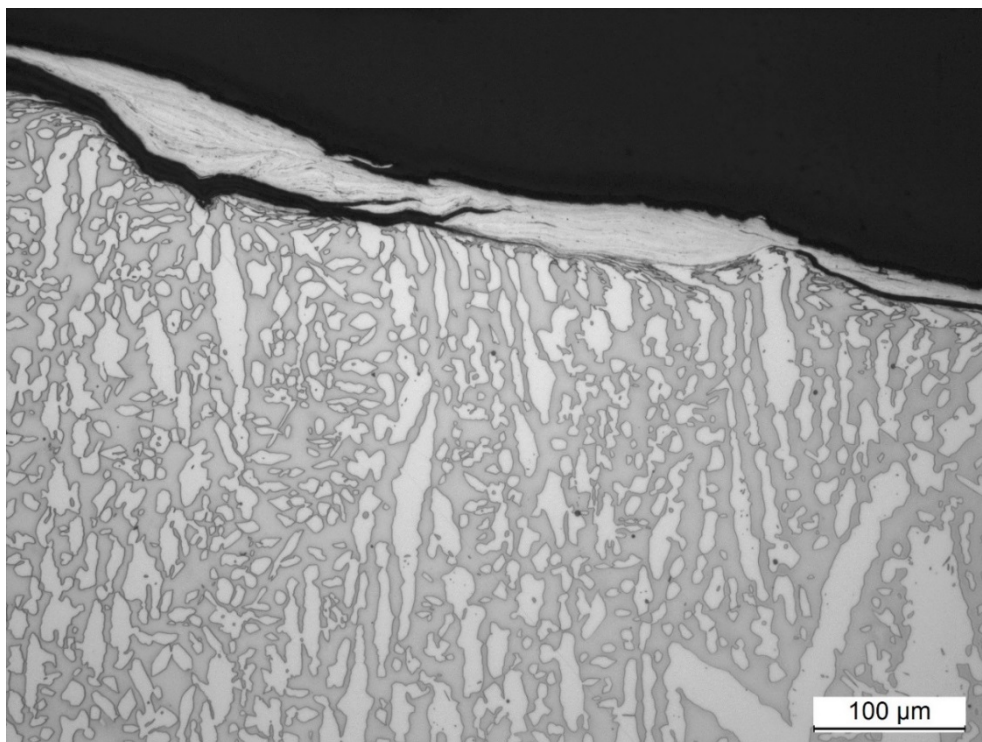
- (iii) A local thin, anomalously deformed and partially torn-off 'alien' surface layer at the plate surface immediately adjacent to the circumferential butt-weld, with a typical parent steel duplex microstructure beneath it (Figure 11).

Figure 11. A local thin anomalous, deformed and torn-off surface layer (white) on the plate surface adjacent to the circumferential butt-weld, typical parent steel duplex microstructure beneath the surface layer.

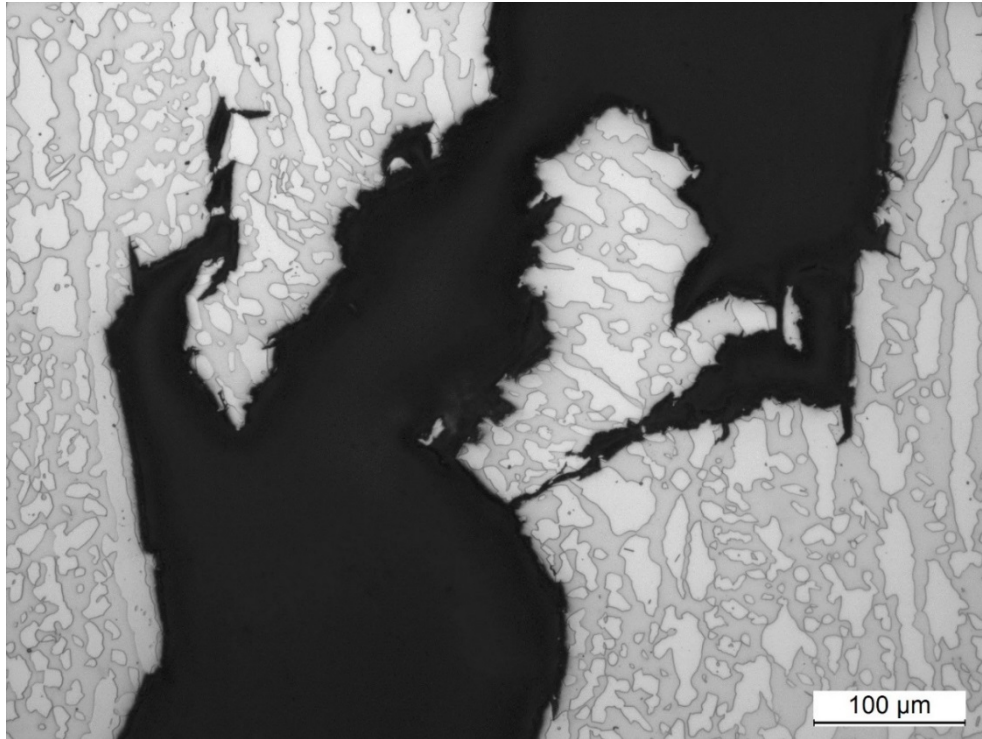
Figure 12. Crack propagation through the circumferentially welded gas separator specimen – propagation path mainly within the ferrite phase (grey) and circumventing the austenite phase (white).

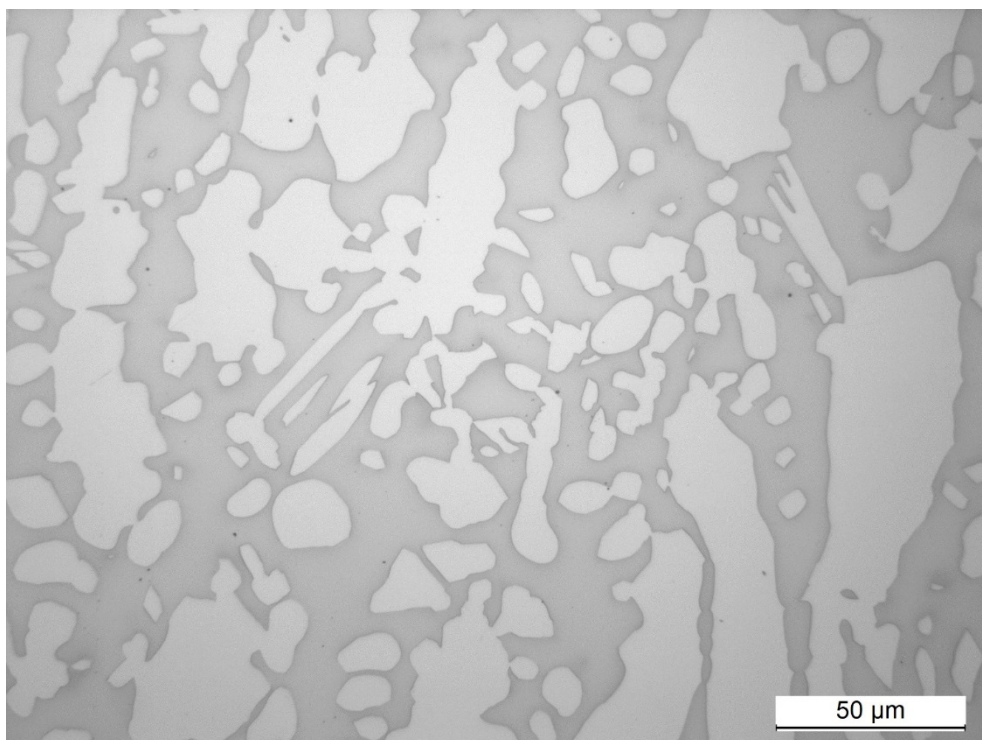
The microstructure of the base material and the weld metal consisted of a mixture of ferrite and austenite and was hence typical of duplex stainless steel. The microstructures also exhibited an appropriate balance between the ferrite and the austenite phases, approximately a ratio of 43/57 (Figure 13).

Figure 13. Microstructure of the base material; ferrite (grey), austenite (white).
